Historic Lighthouse Preservation Handbook

1997

Introduction

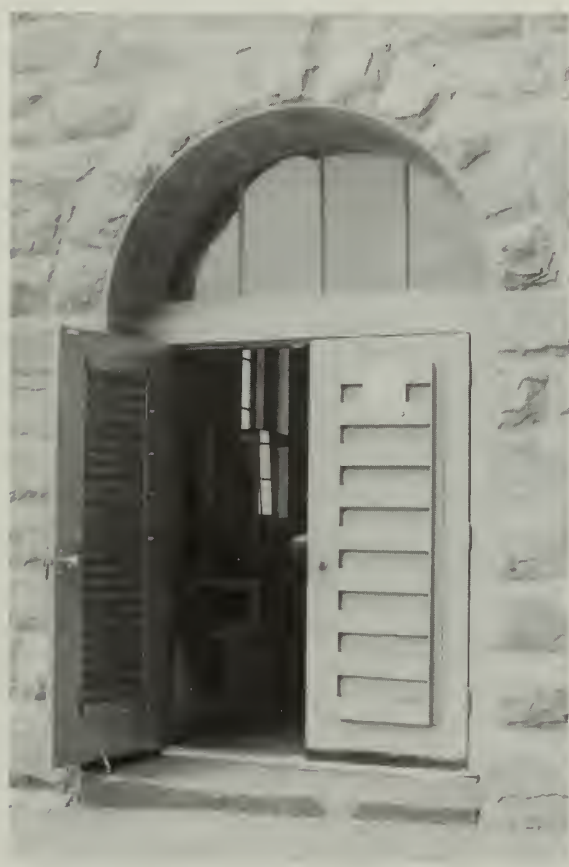
Figure 11. These louvered doors have been installed at Point Sur Light Station for security and ventilation. Note the baffles on the exterior and the screened louvers on the interior.

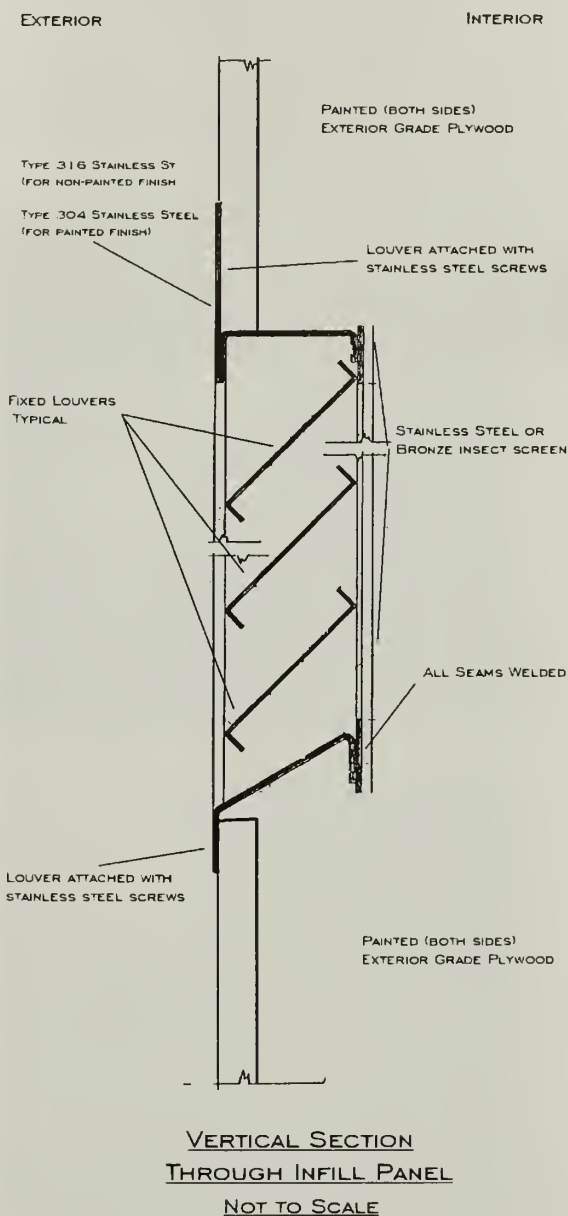
Figure 12. Typical detailing of a 'storm proof' louver for temporary lighthouse doors. (WPTC image adapted from drawing from USCG-CEU Oakland Archives)

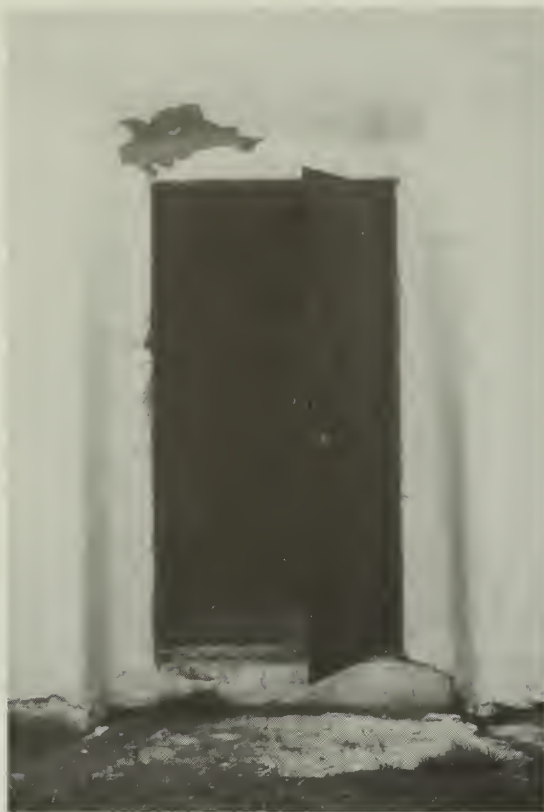
Figure 13. Site-built steel door at the Turkey Point Lighthouse; this solution was chosen because of the remote location and repeated break-ins. Note exterior stiffeners and shroud over the hasp and lock.

Site-built, fabricated steel door: This door consists of a steel 'C' channel frame set into the existing opening that is lag-bolted to the existing door frame. On the outside of this frame, the door leaf is connected by welding the hinges to both the frame and door leaf. The door leaf should overlap the opposite door frame to facilitate the installation of an eye that will pass through a slot in the door leaf to facilitate a lock. A steel shroud big enough to facilitate lock operation with a key, but prevent bolt cutters from reaching the lock, should be welded over top of the eye slot. If the lighthouse is not in an area that is to be wave swept (i.e., if the lighthouse is located on a breakwater or pier), the door should be fitted with screened louvers that are approximately 25 percent of the total door area. The louvers

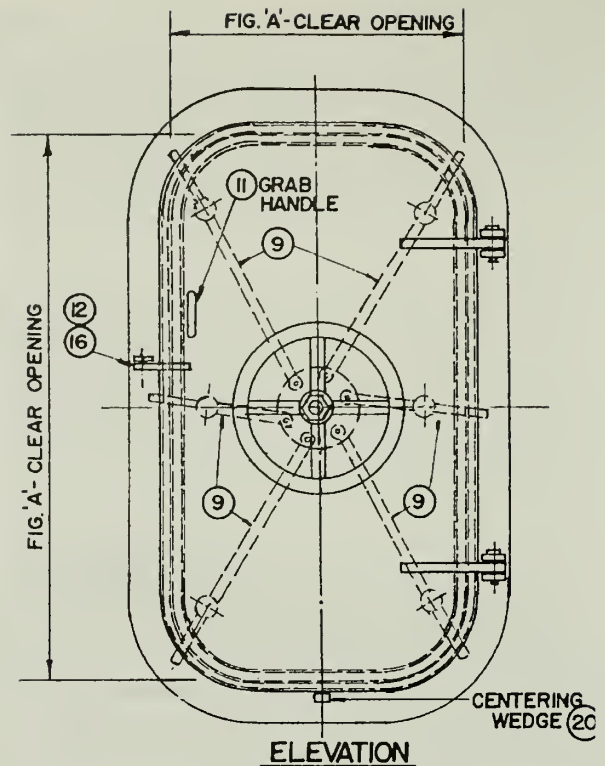
Figure 14. A shop drawing depicting the parts of the watertight 'ship' style door. (Drawing courtesy of Cen-Tex Marine Fabricators)

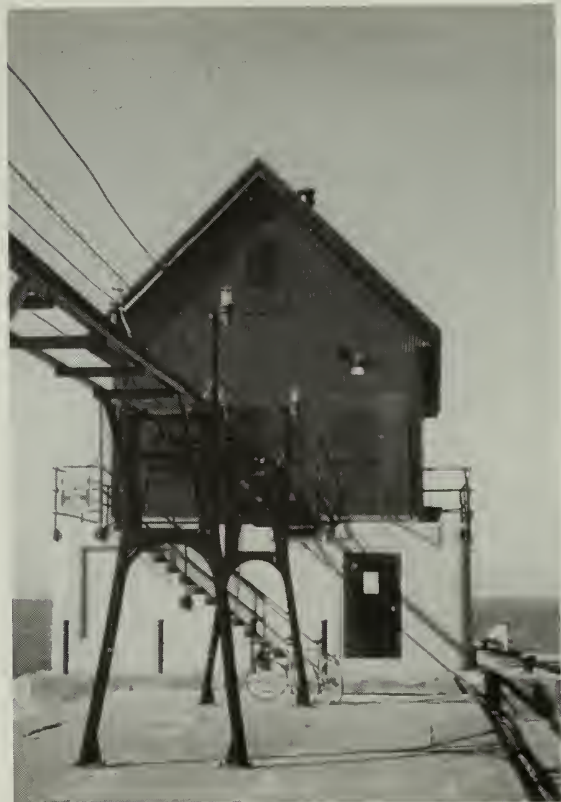
Figure 15. View of watertight 'ship' style door installation on the Grand Haven South Pierhead Front Range Light, Grand Haven, Michigan.

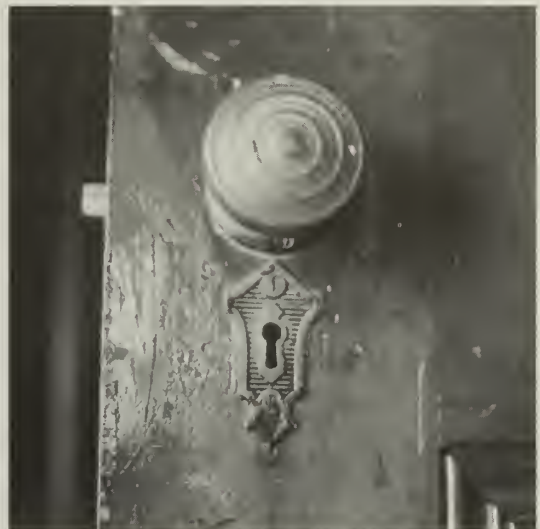
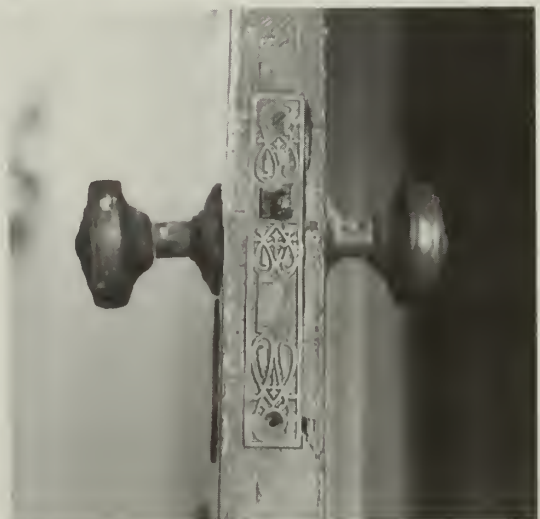
Figures 16 and 17. Examples of decorative door hardware found in late 19th-century lighthouses.

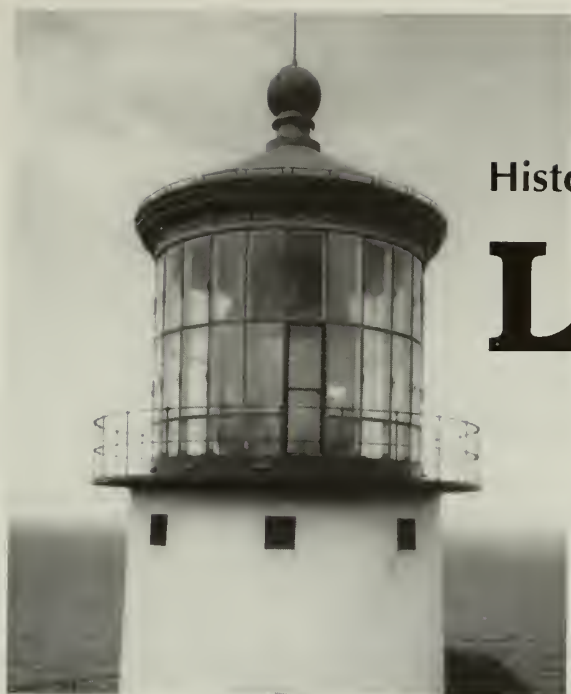
Figure 1. Lantern housing hyper-radiant lens at Makapuu Lighthouse near Waimanalo on the Island of Oahu in Hawaii

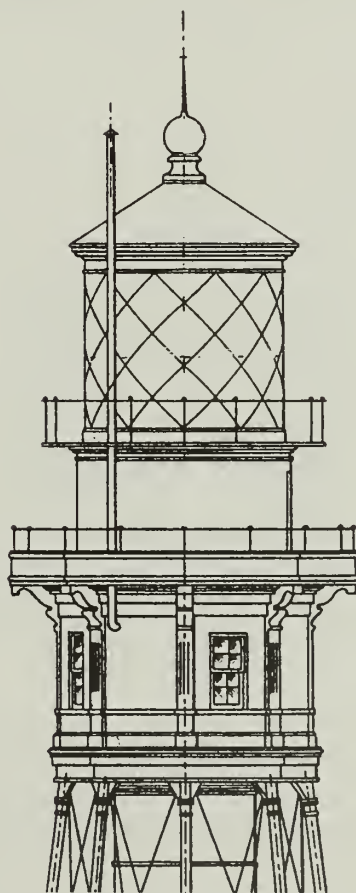
Figure 2. Original construction drawing of the first-order Cape Fear Lighthouse showing the lantern above the service/watch room.

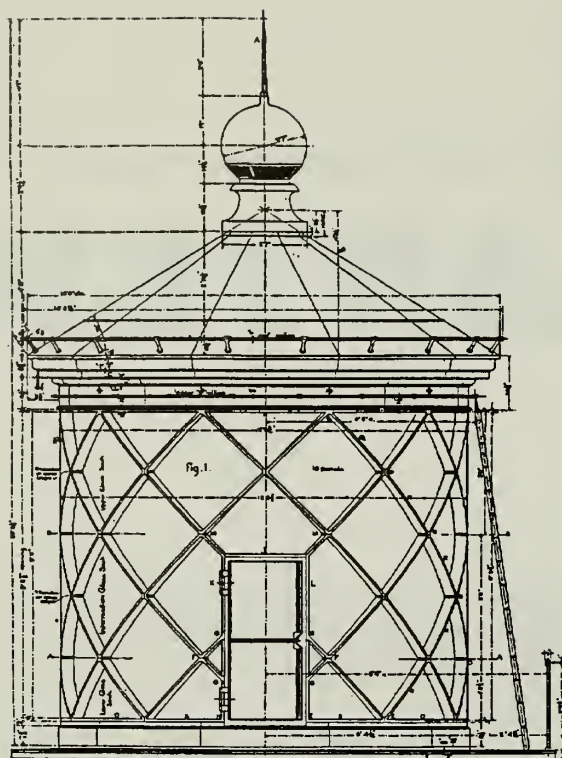
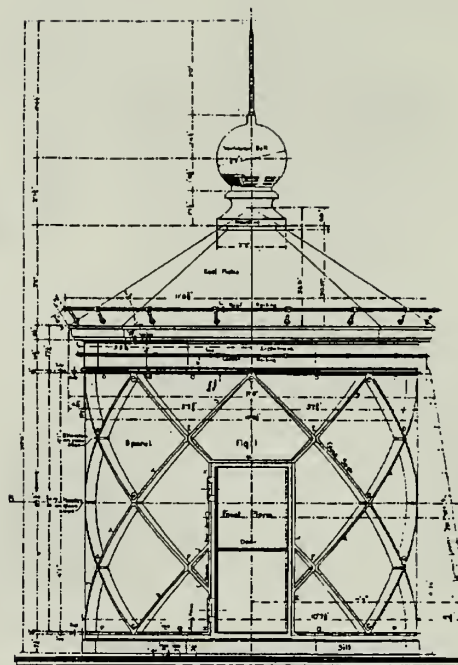
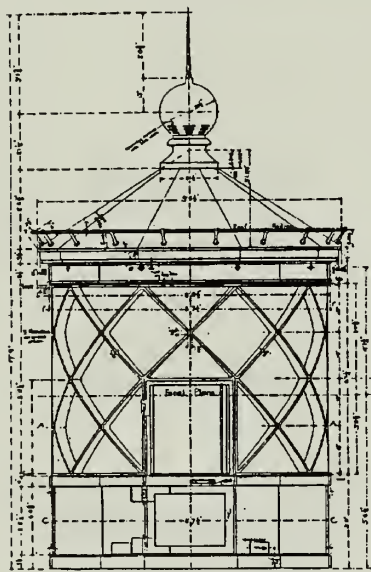
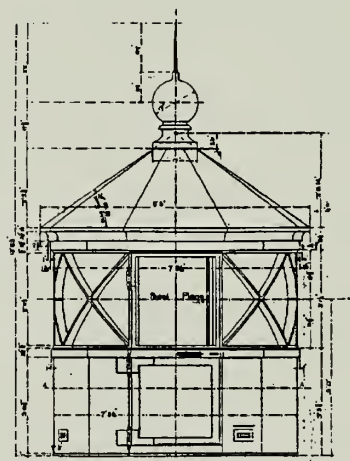
Figure 3. Illustration of the four standard lantern sizes used by the U.S. Lighthouse Establishment in the first half of the 20th century. Drawing assembled by WPTC from images dated 1898 and 1903 courtesy of USCG CEU Oakland.

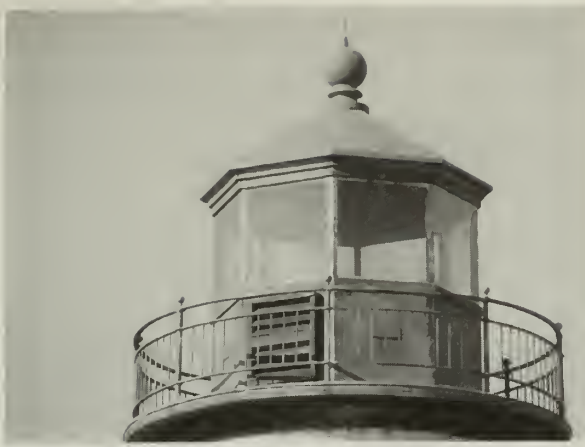
Figure 4. Close-up of the fourth-order lantern at Coquille River Lighthouse in Oregon.

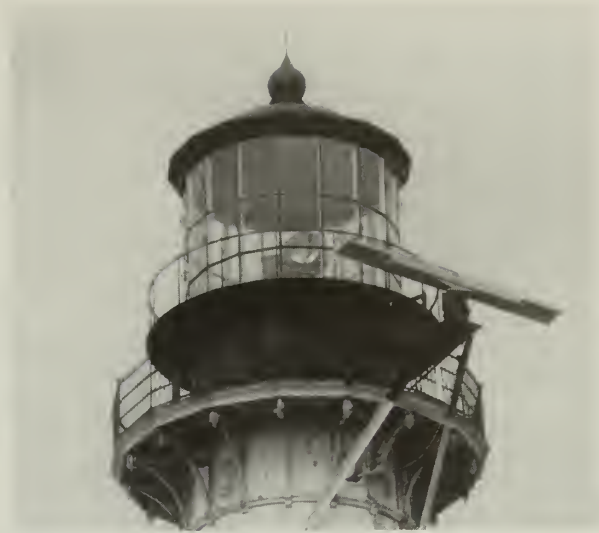
Figure 5. Close-up of the first-order lantern at Cape Canaveral in Florida.

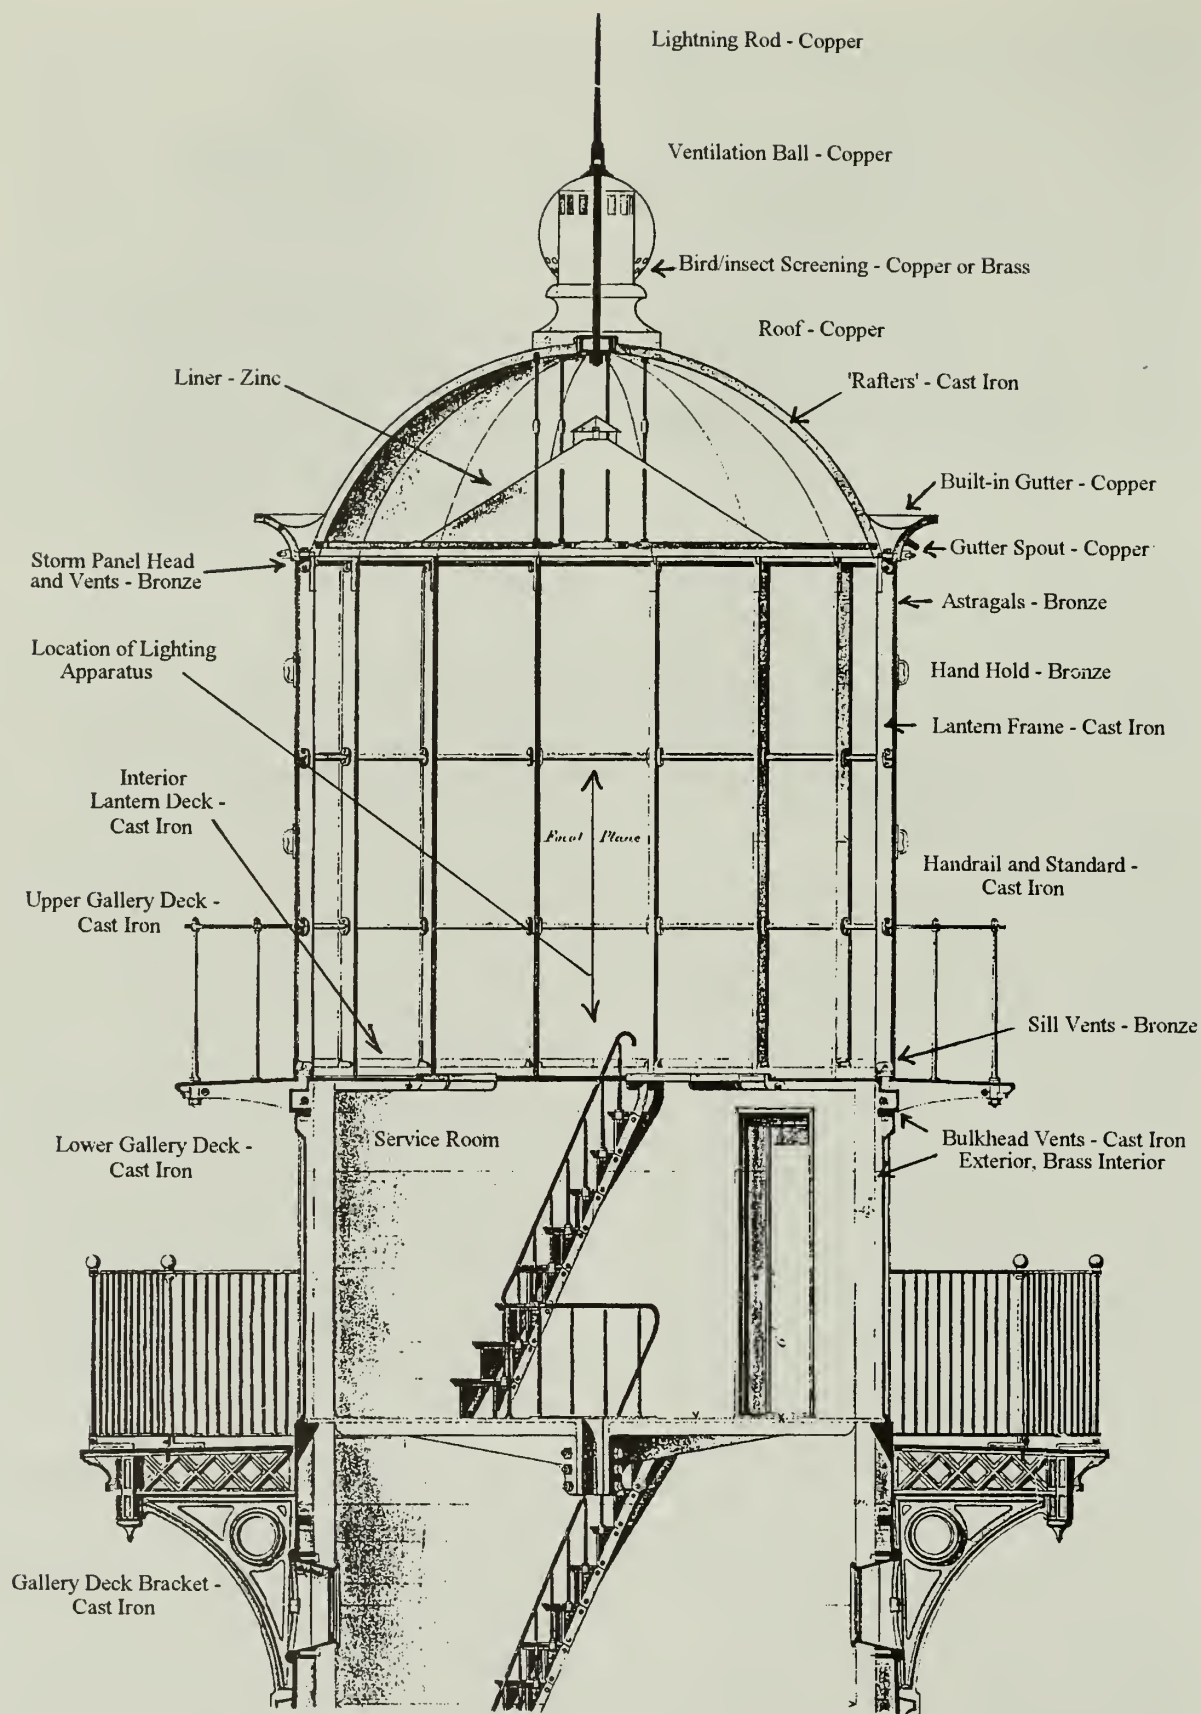
Figure 6. Diagram of a typical first-order lantern; the parts are similar to second- and third-order lights. (Diagram based on USLHS drawing in the National Archives)

In order to withstand harsh weather conditions, the components of a typical lantern are made from a variety of materials and metals. The main support structure (including the floor), certain types of parapet walls, and the lens pedestal are typically made of cast iron for strength. The roof, ventilation ball, and lightening rod are typically made of copper, which can withstand severe weathering (and in the case of the lightning rod, can conduct electricity). The astragals and clamps that hold the lantern glass in place as well as grab handles are typically made of bronze which resists corrosion and is durable. Brass screws compatible with the bronze are typically used to attach the astragals to the lantern frame. If these parts corrode, damage to the lantern glass can result.

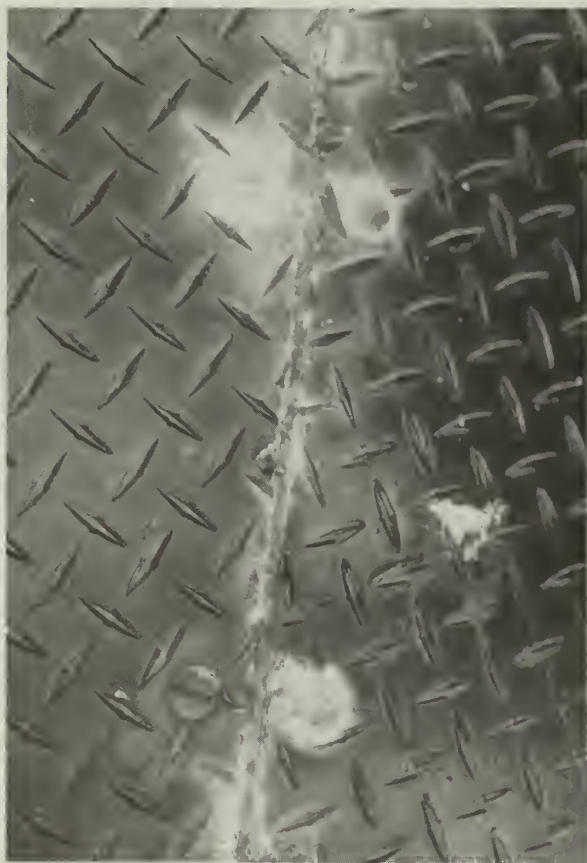
Figure 7. The white chalky residue around the steel bolt heads on this aluminum deck is the by-product of the corrosion occurring at these connections.

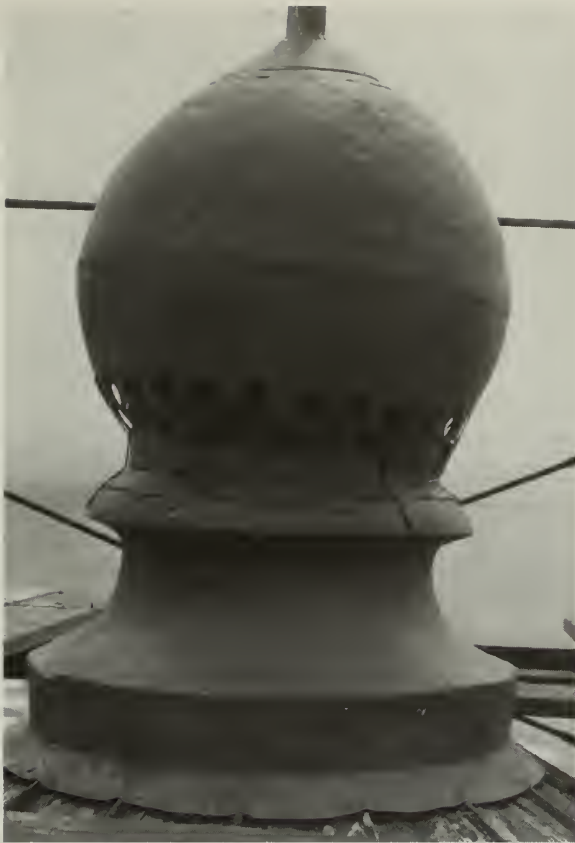
Figure 8. Despite the fact that this first-order lantern ventilation ball has been repaired several times, it still provides adequate lantern ventilation.

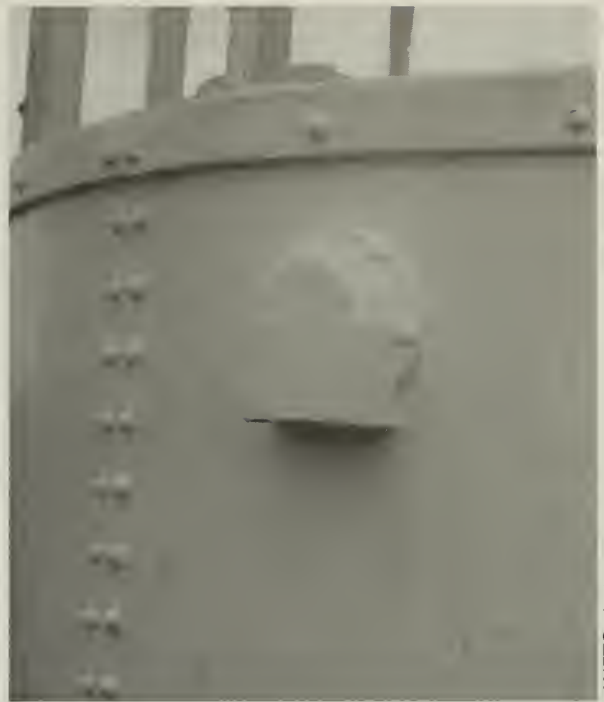
Figure 9. An example of a parapet-wall-mounted vent on a fourth-order lantern.

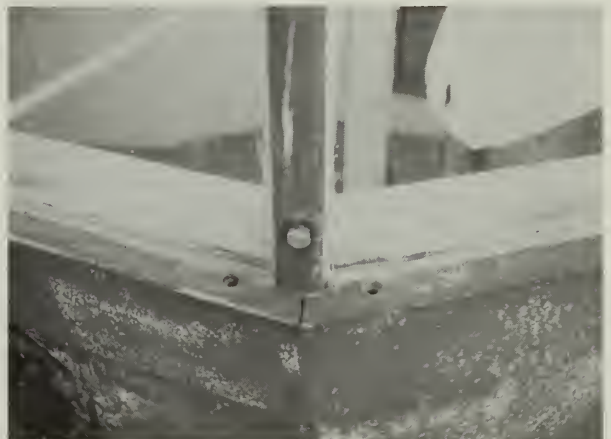
Figure 10. Close-up of missing clamp bolts; these bolts should be replaced to keep this area weather tight.

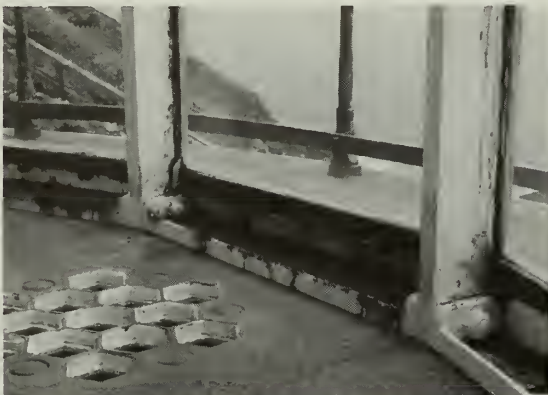
Figure 11. The water that has collected in this lantern sill is causing the iron lantern glass frame (the vertical members in the center of the photo) to rust and corrode.

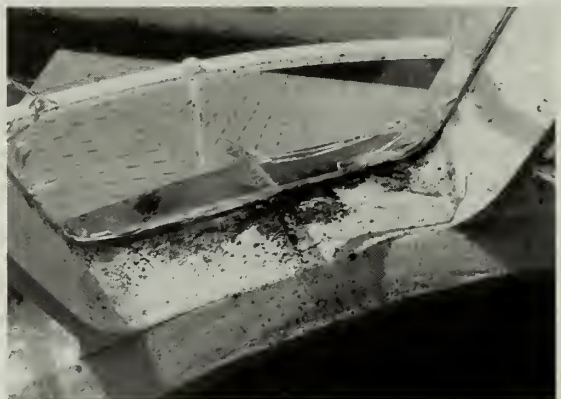
Figure 12. The glass in this lantern has been cracked by the rust-jacking that is occurring along the iron frame.

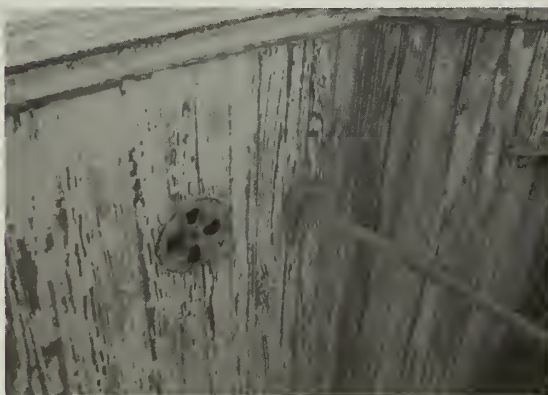
Figure 13. The paint coating that once protected this lantern parapet wall has failed.

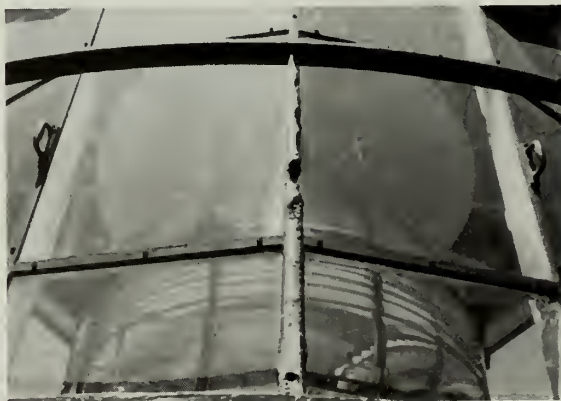
Figure 14. Wind and airborne sand have accelerated the deterioration of this lantern gallery deck handrail

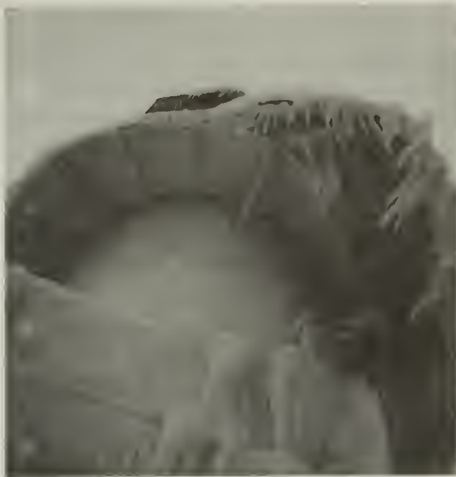
Figure 15. Close-up of ice on St. Joseph North Pier Lighthouse causing damage to gallery deck and handrail.

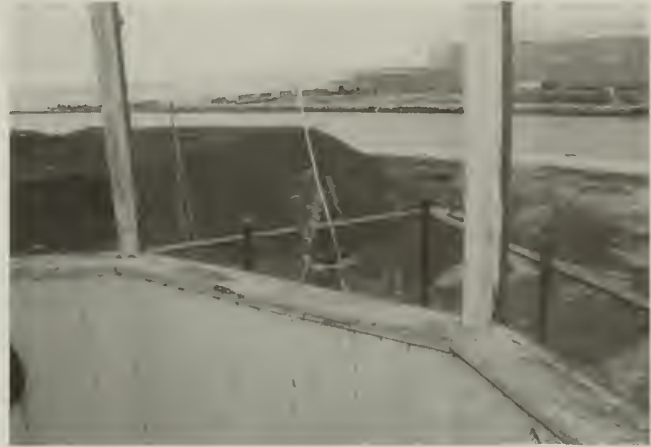
Figure 16. This lantern glass has been damaged by rock-throwing vandals. The resulting hole is allowing rain and insects to enter the lantern.

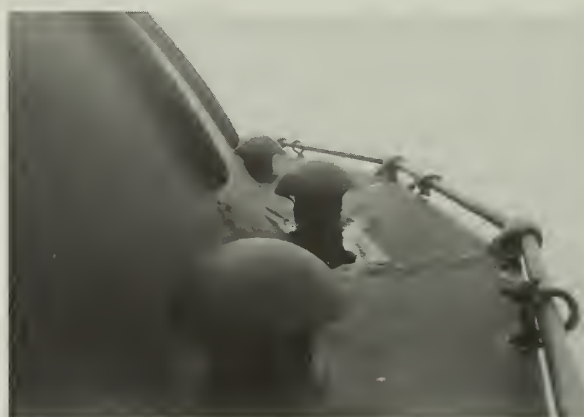
Figure 17. Roof vents such as these should be inspected for leaks and maintained during the mothballing period. This shroud-style vent allows air to pass while preventing rain from entering.

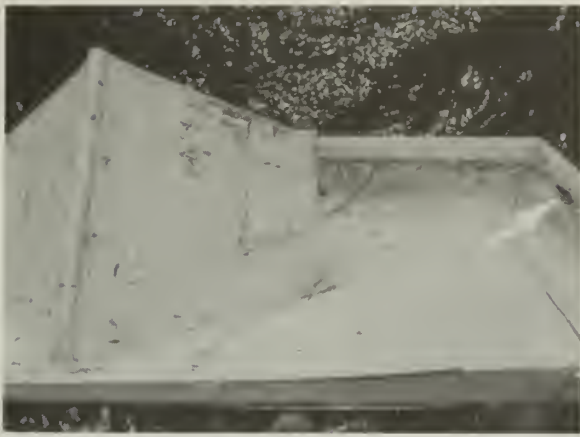
Figure 18. View of built-in gutter on a caisson lighthouse; arrow indicates fist-size hole. This condition must be treated before mothballing.

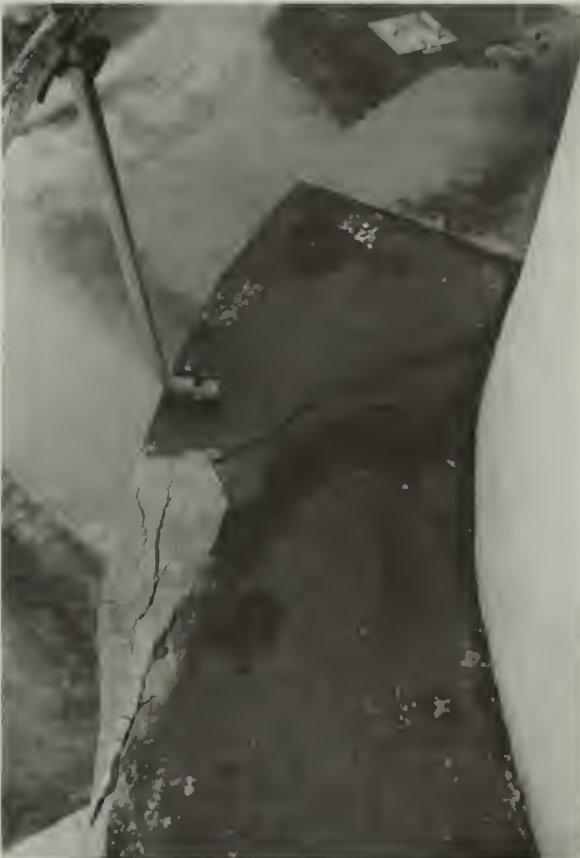
Figure 19. The repair made to this stone gallery deck has begun to deteriorate; moisture penetration is occurring. This condition should be addressed before mothballing.

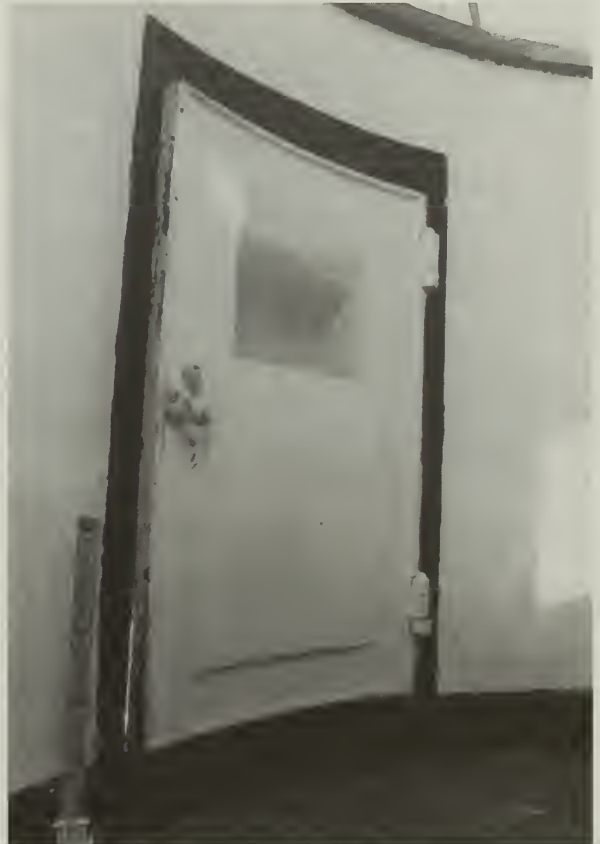
Figure 20. Close-up of a vented parapet hatch in a fourth-order lantern. The hatch should have a good seal and still remain operable. The built-in vent should also be kept open to maximize ventilation of the lantern and tower.

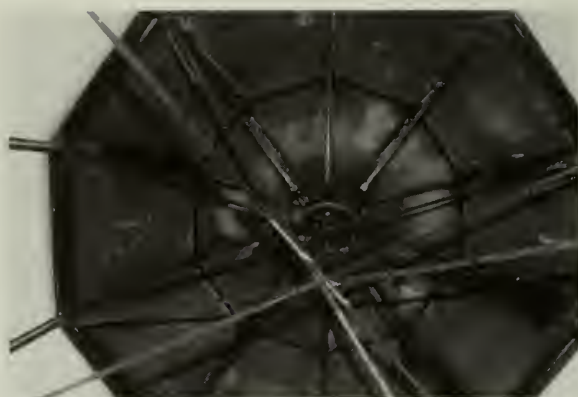
Figure 21. The diagonal tension rods in this empty lantern were installed to brace the lantern against lateral loading caused by high winds.

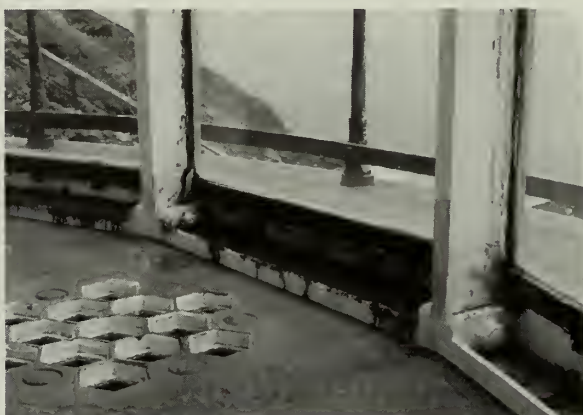
Figure 22. Close-up of sill vents in a first-order lantern. The vents should be kept open during the mothballing period to maximize lantern and tower ventilation.

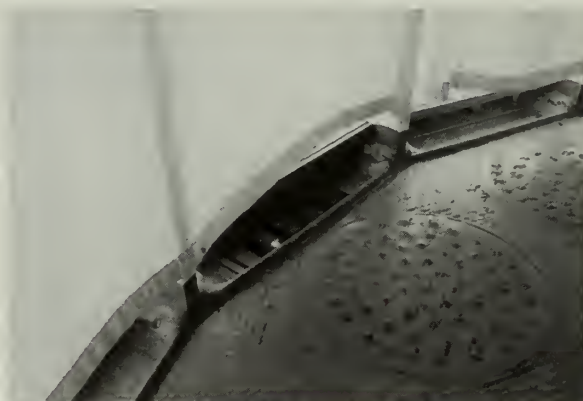
Figure 23. As part of the lantern mothballing treatment the lantern glass sill vents should be kept open (except in extremely damp climates) to allow for the free flow of air through the lantern.

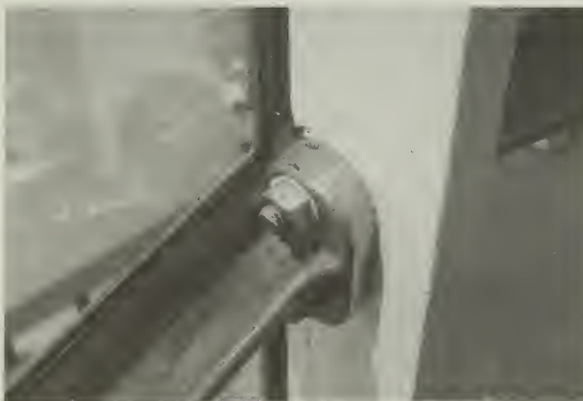
Figure 24. The stainless steel through bolts used to join this bronze sash bar to the vertical lantern post is isolated from the bronze using a nylon washer as a barrier.

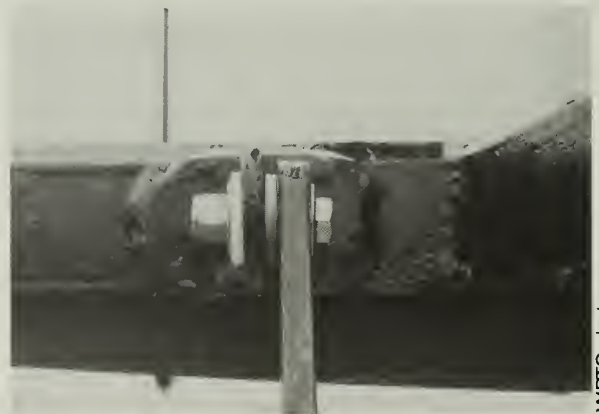
Figure 25. This is a view of a typical dissimilar metal isolation solution; the steel ladder post (vertical member in the center of the image) is isolated from the aluminum lantern gallery deck with nylon washers. The bolt chosen for this application is made from Type 316 stainless steel.

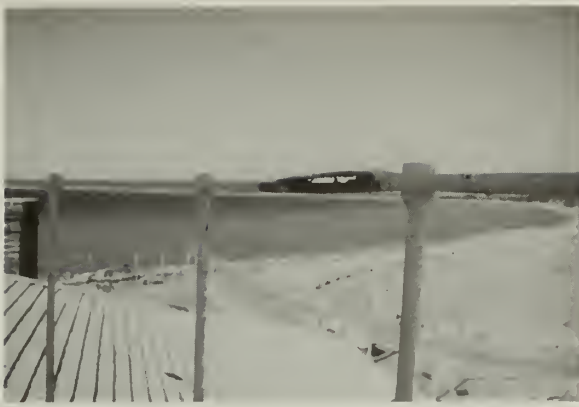
Figure 26. Detail of handrail that is being deformed by rust-jacking.

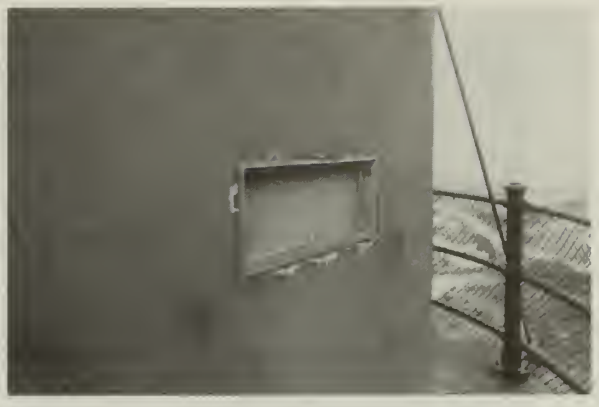
Figure 27. This lantern vent opening has been covered with a fine stainless steel screen that prevents insect infiltration while maximizing air movement through the vent and into the lantern.

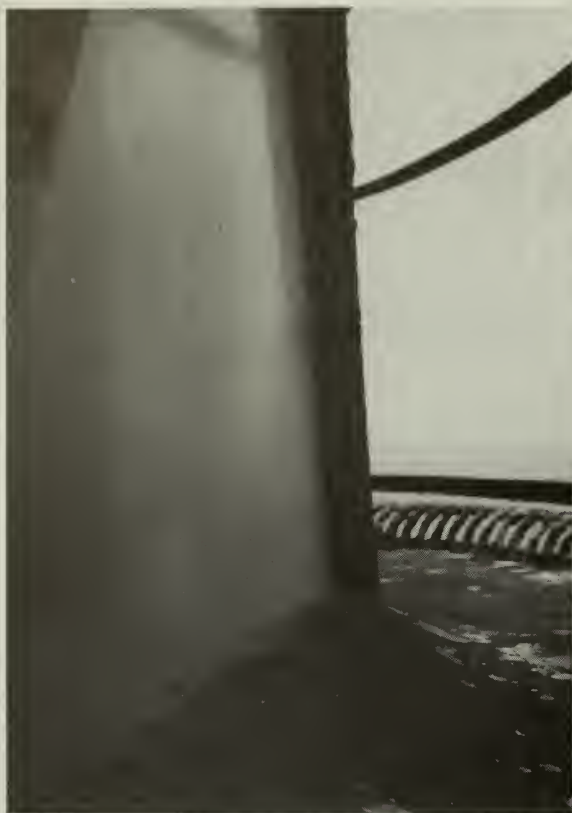
Figure 28 (top left). Close-up view of severely hazed Lexan replacement panel. Note the limited visibility caused by only ten years of sunlight and salt air exposure.

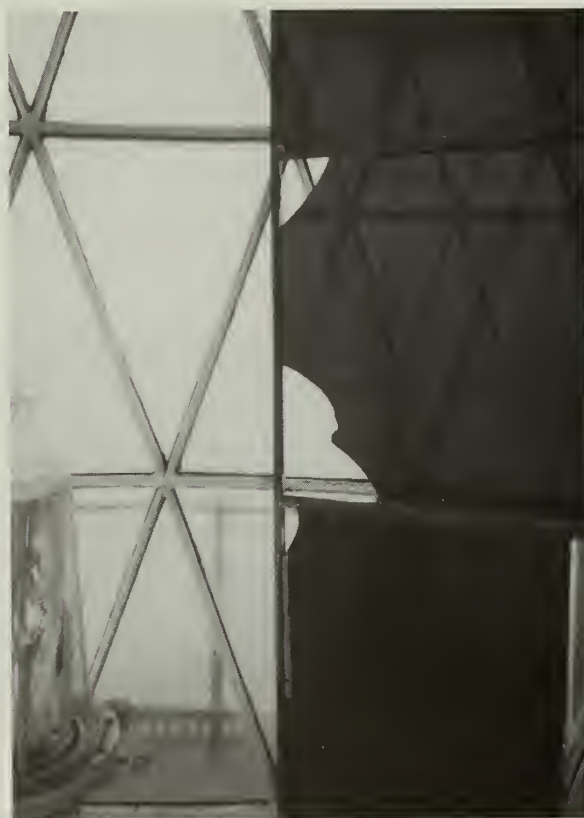
Figure 29 (bottom left). Looking out through severely hazed Lexan panels, note the limited amount of light transmission; this greatly hinders the effectiveness of the aid to navigation. If the panels are not replaced, the degradation may continue and diminish the light transmission, ultimately rendering the aid to navigation ineffective.

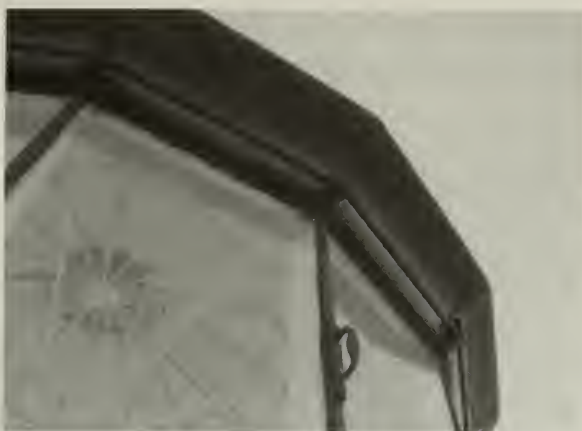
Figure 30. Close-up of a first-order lantern that retains its lantern glass; note the clarity.

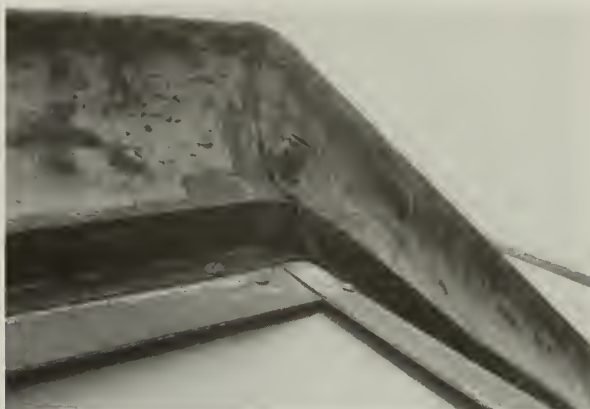
Figure 31. View of built-in gutter spout on a copper roof.

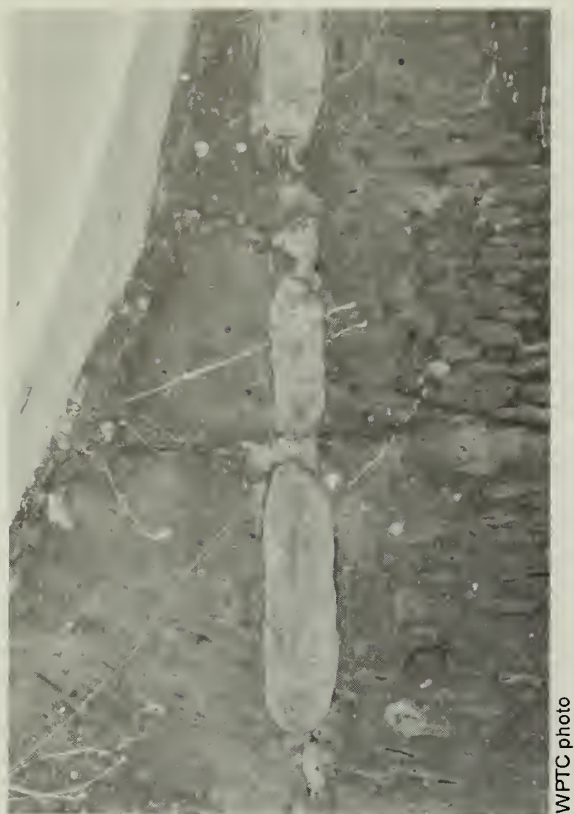
Figure 32. This sheet-copper-covered lantern gallery deck has been repaired several times by soldering sheet copper patches over the holes. This method of repair, if performed properly, greatly increases the life span of the roof covering.

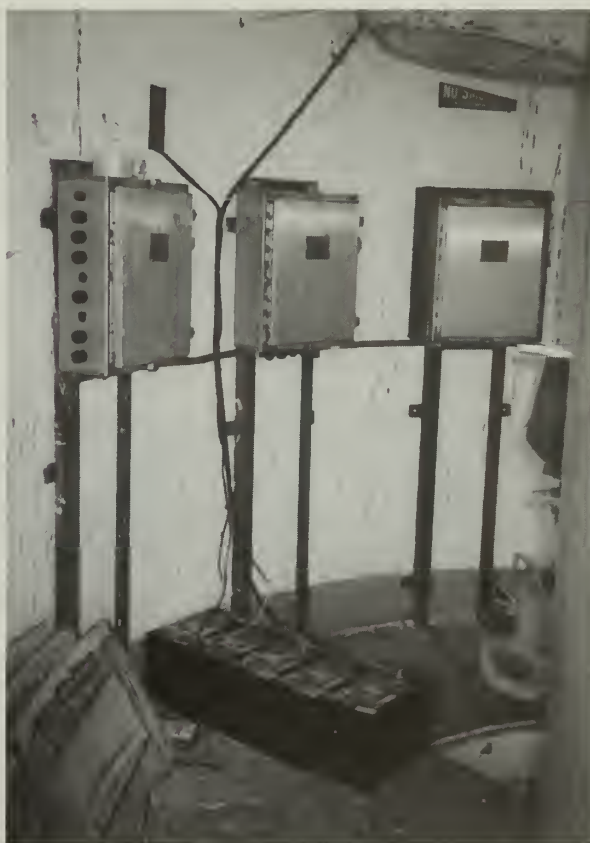
Figure 33. To minimize damage to historic wood beadboard panelling, these new panels should have been installed on a sheet of plywood attached to the historic wood beadboard panelling in four locations. These batteries stored on the floor should be in containment boxes in case the batteries leak.

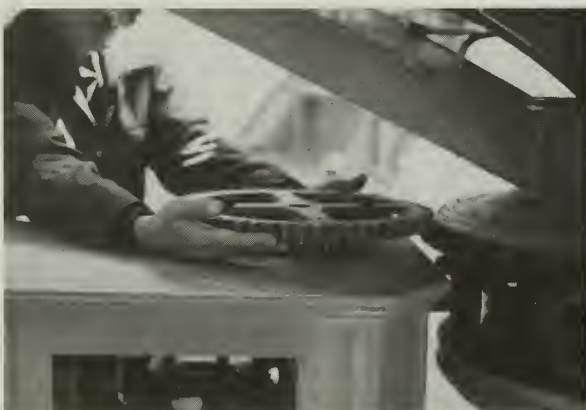
Figure 34. When this first-order classical lens was converted to AC power, the original drive gear (pictured here) was the crank used to wind the clockworks.

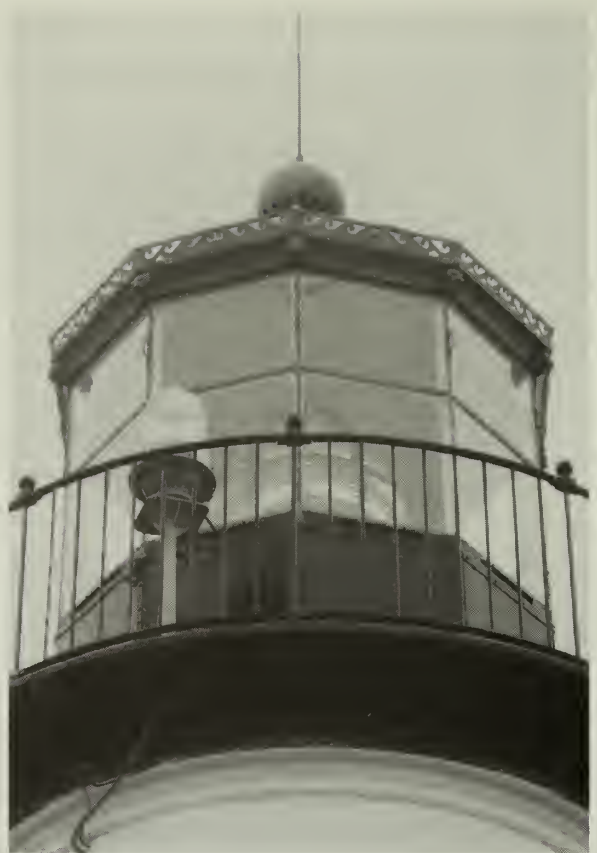
Figure 35. This is an acceptable auxiliary light installation. The light is mounted on an aluminum pedestal that has been bolted to the replacement aluminum deck.

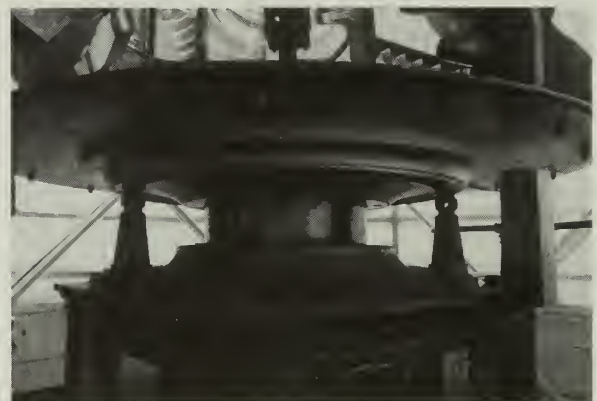
Figure 36. This c. 1926 lens was designed to be AC powered; the original lens jacks are still in place. The three jacks (the third is obscured by the brass bearing cover) were used to lift the lens assembly so that bearings could be serviced.

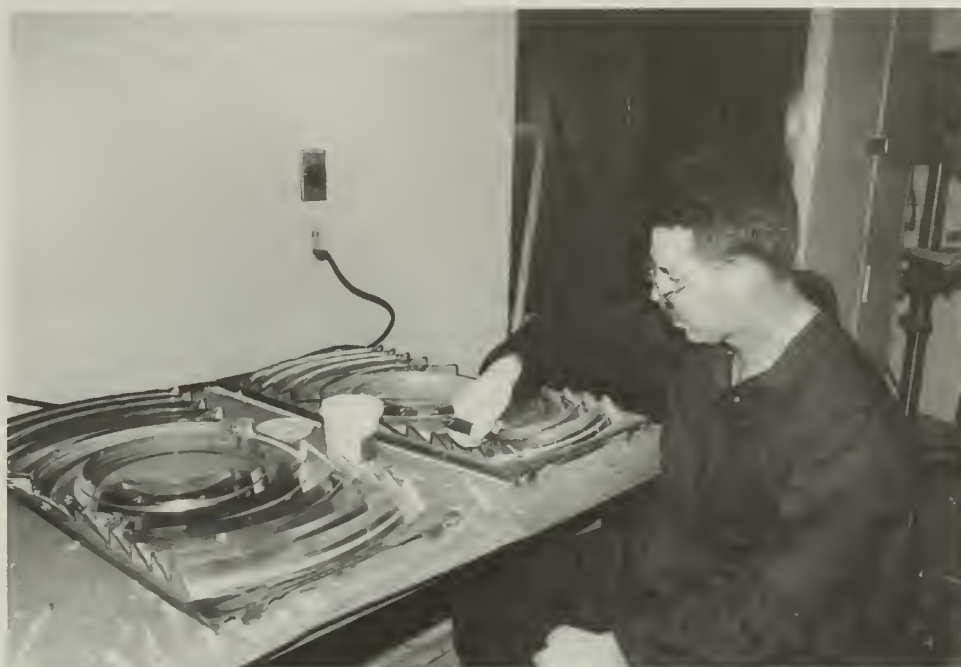
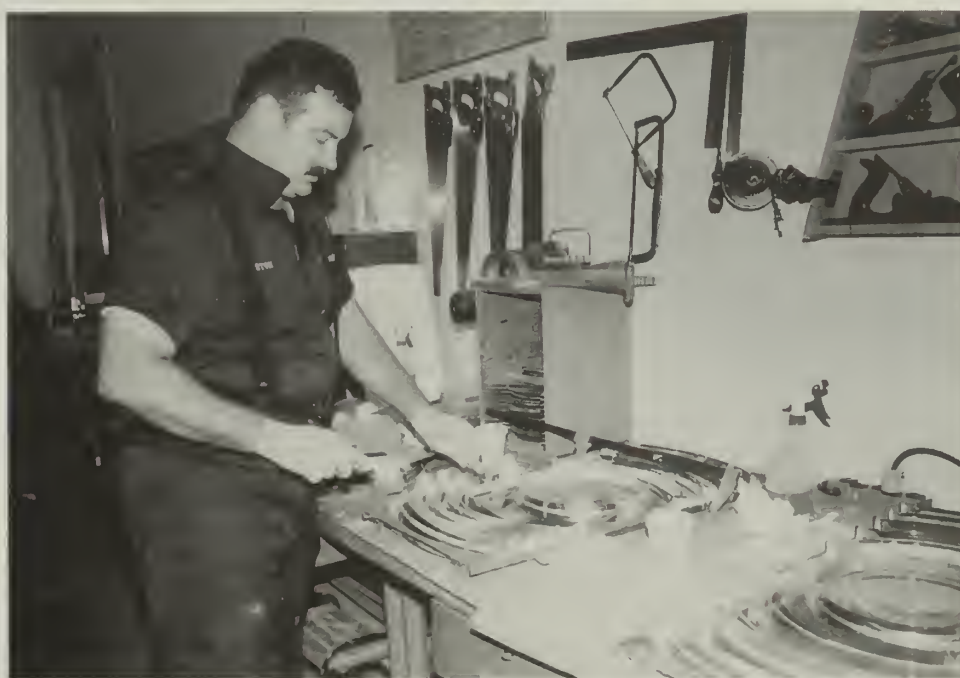
Figures 37 and 38. Joe Cocking (above) and Nick Johnston (below) restore a classical lens at the U.S. Coast Guard Exhibit Center.

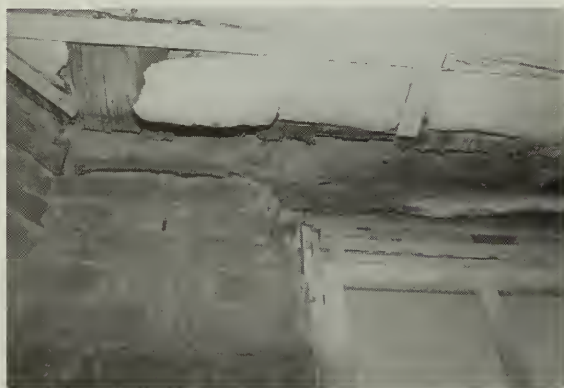
Figure 4 (left). Extensive interior finish deterioration in a lighthouse that had holes in the roof which were not repaired.

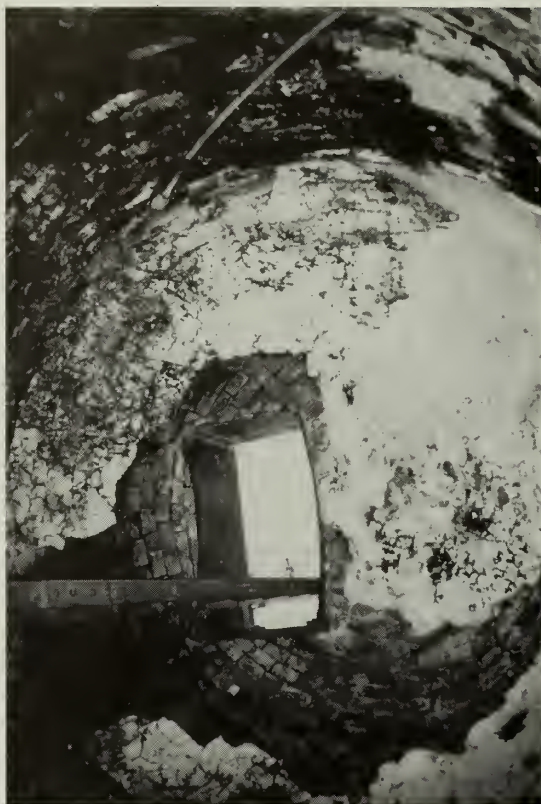
Figure 5 (above). Excessive condensation buildup in this lighthouse caused the interior plaster finish and some mortar joints to fail.

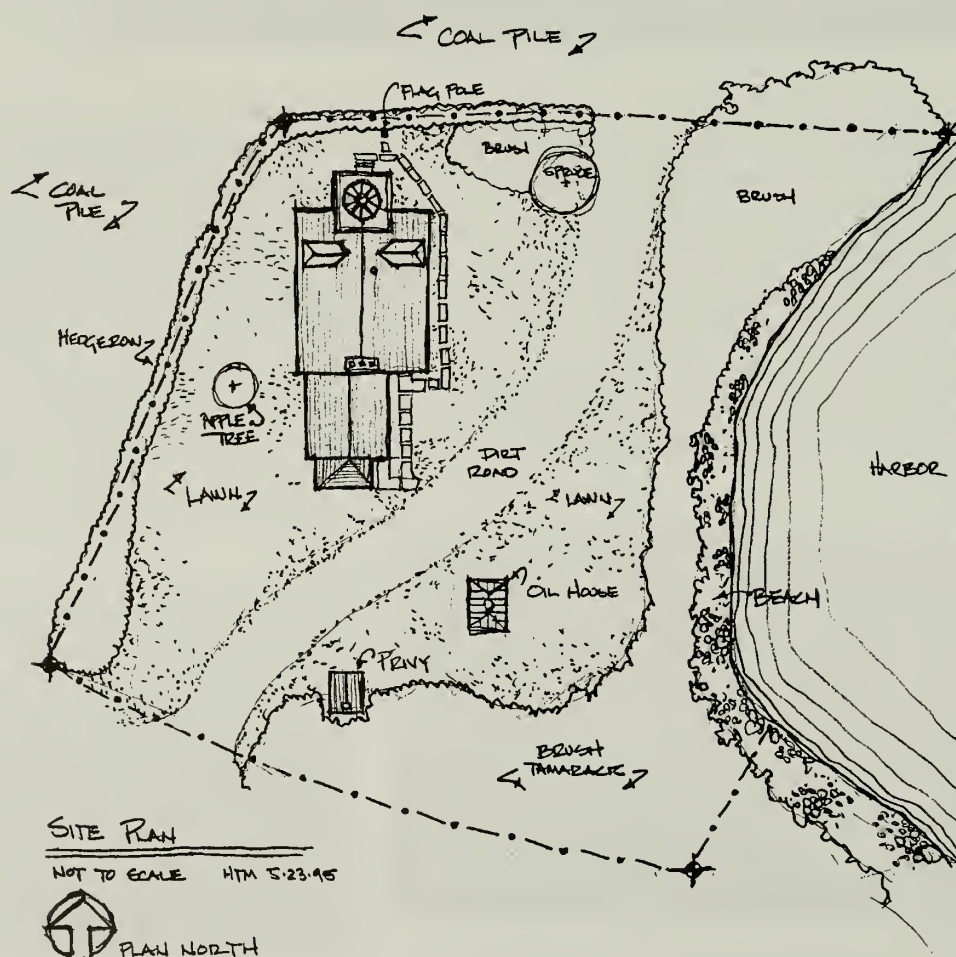
Figure 5. A simple sketch site plan records the relationship of a light station's buildings and features. This type of recordation should be dated and filed with the lighthouse maintenance records. (WPTC drawing by H. Thomas McGrath)
